HEALROAD Symposium

HEALROAD industrial upscaling and full scale demonstrator

test section on duraBASt

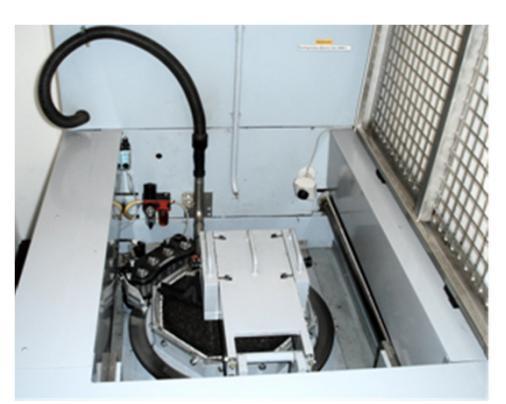
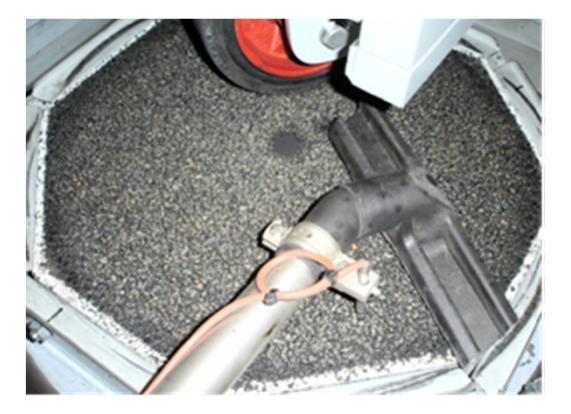
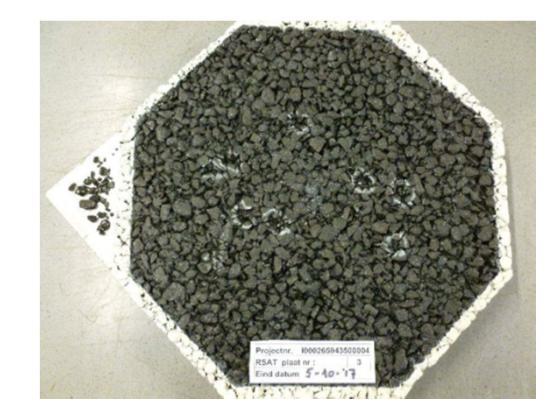
2. Ravelling test at the PA variant: Rotating Surface Abrasion test (RSAT)

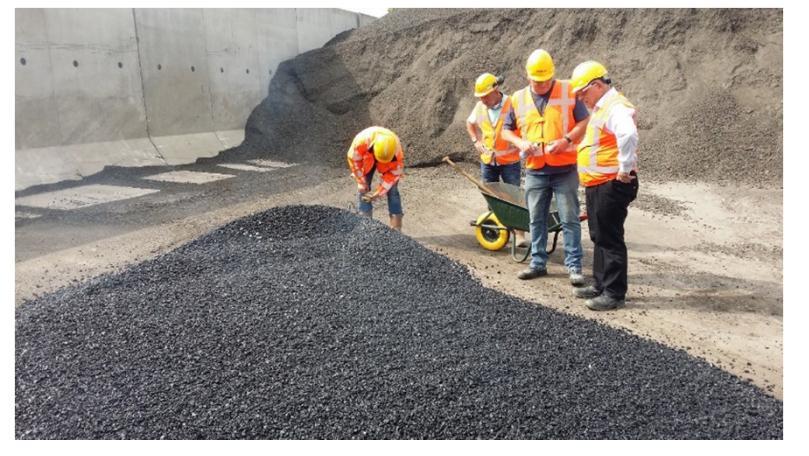
Determining the correct mixing procedure in a asphalt production plant

Several mixing-variants, produced in an asphalt plant \rightarrow mechanical tests

- → No special and exceptional procedures are needed to produce the HEALROAD mixtures (15 sec longer mixing process)
- \rightarrow Standard production plant is suitable with the usual way of adding additives
- → Positive factor for the introduction of HEALROAD mixes in the European asphalt market

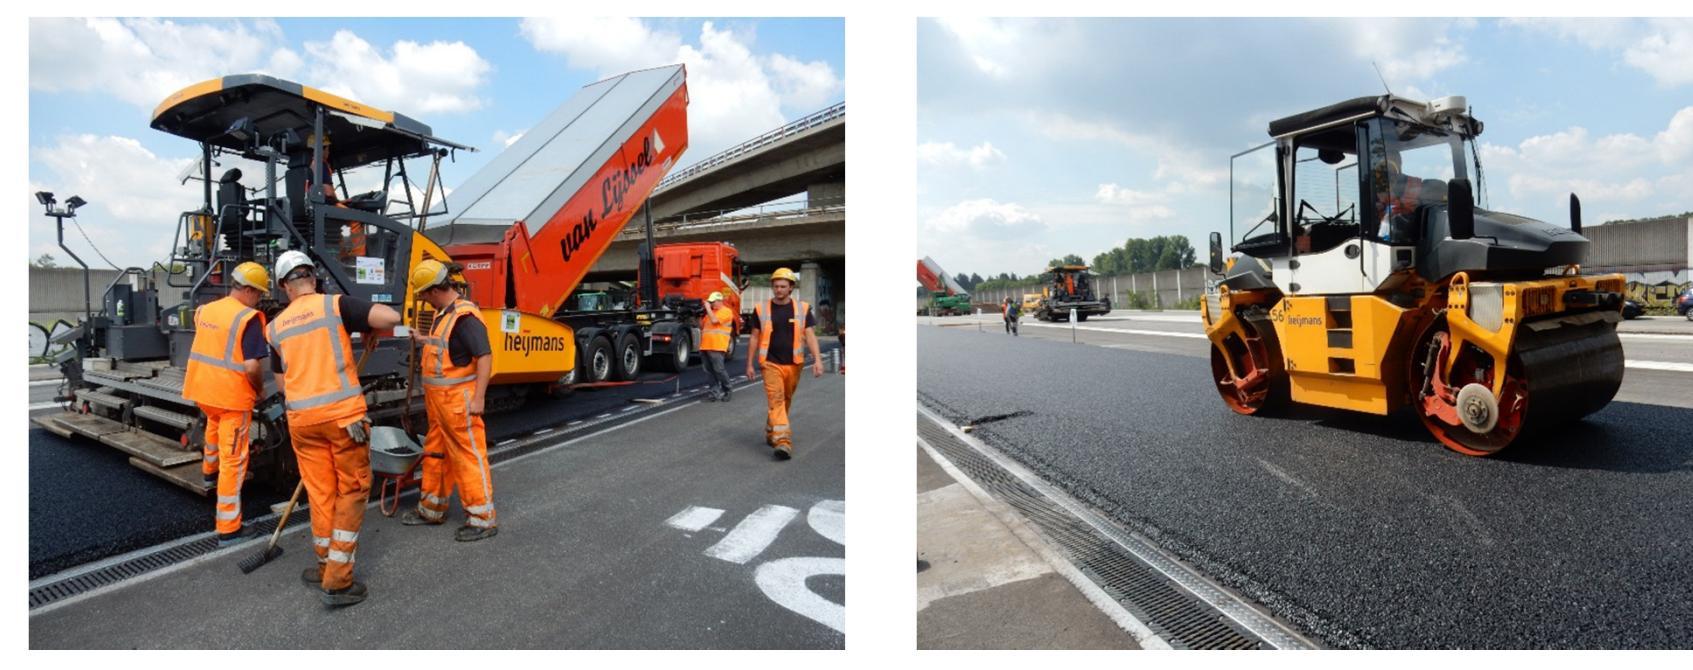
• transport to duraBASt, laying and compaction

\rightarrow special attention to temperature (no segregation) / compaction in the correct window

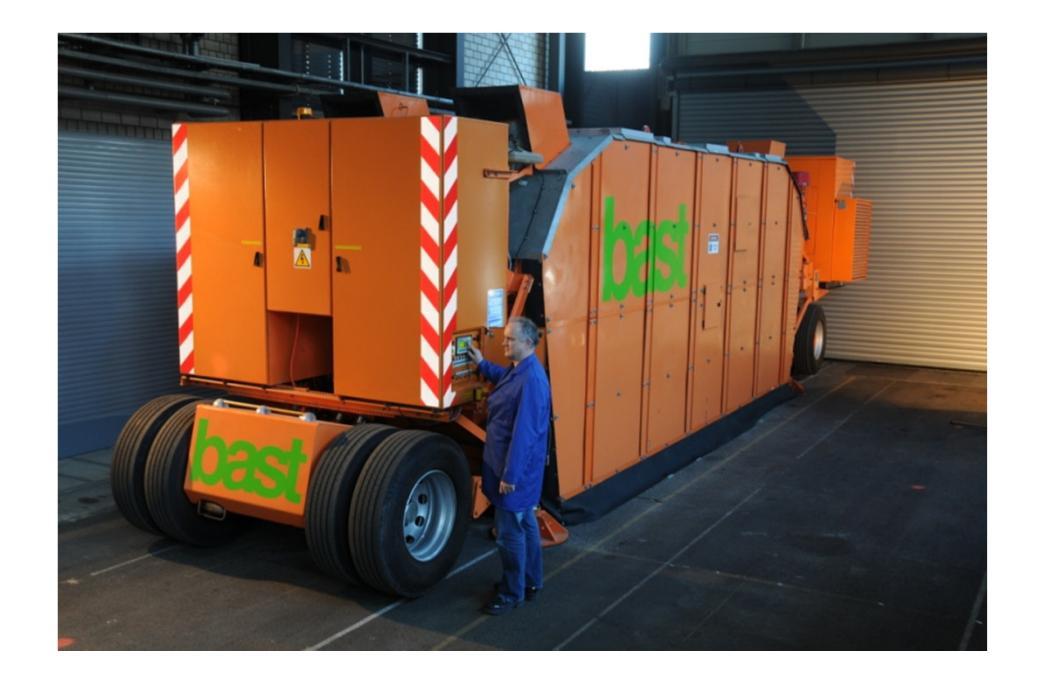
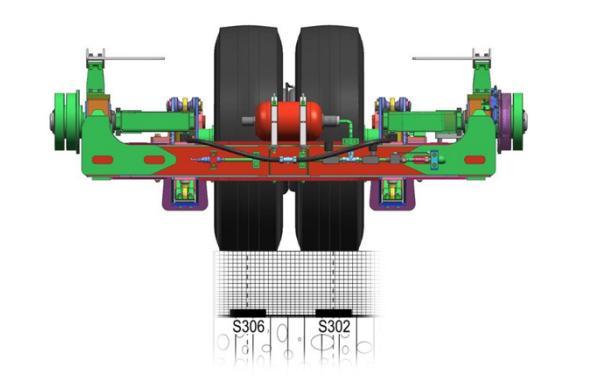
- Accelerated Pavement Testing (APT)
 - Mobile Load Simulator MLS30
 - Super-Single (9.0 bar)
 4 loading wheels in closed chain
 - load = 75 kN
 speed = 7 km/h = 2000 cycles/h
 - lateral unite

±350 mm left and right (one whole program need approx. 12min)

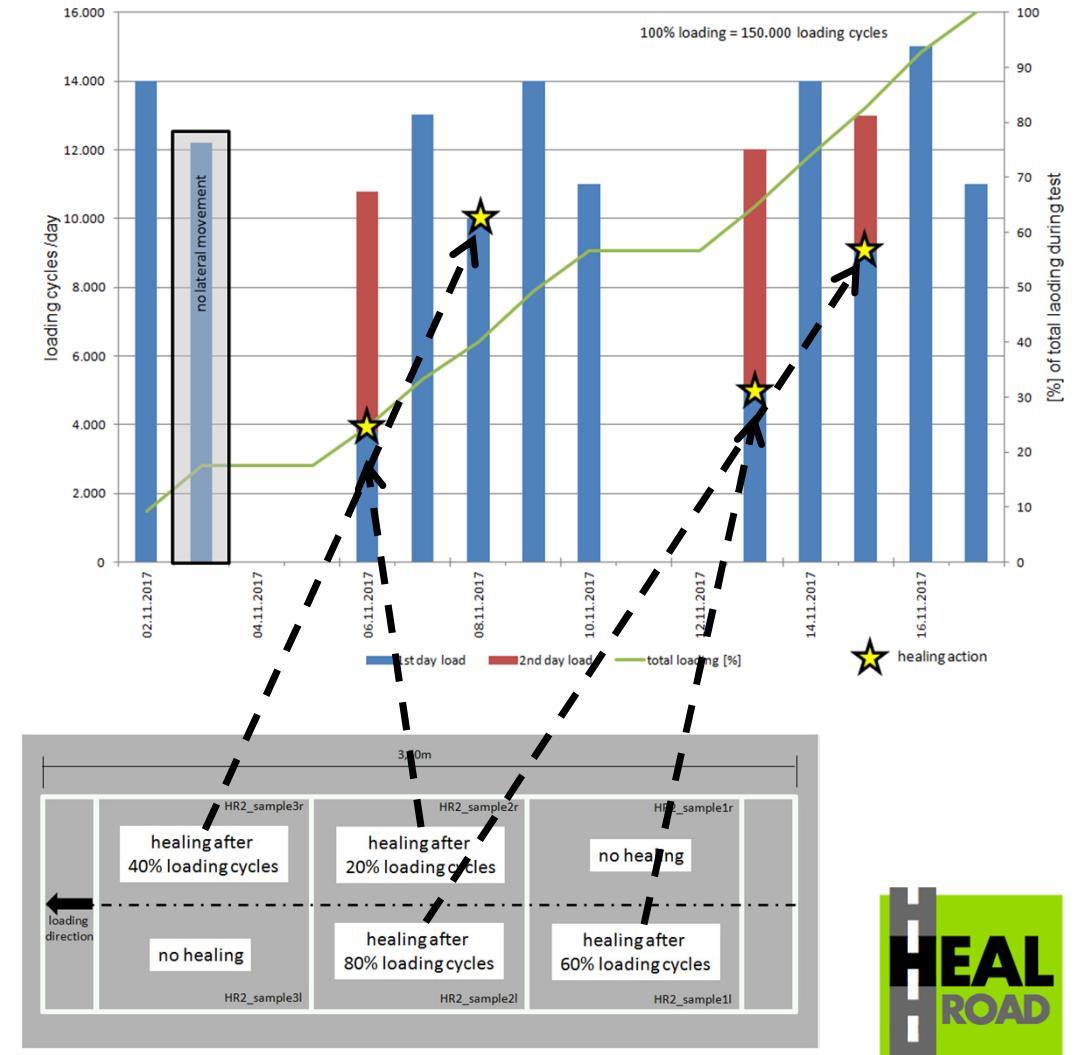
- failure criteria = stone loss
- HEIJMANS laboratory test with RSAT
 - 4 samples laboratory production
 - 4 samples duraBASt production
- BASt used one loading area for healing actions (performed by SGS)
 - no healing at two samples
 - healing on four samples different moments

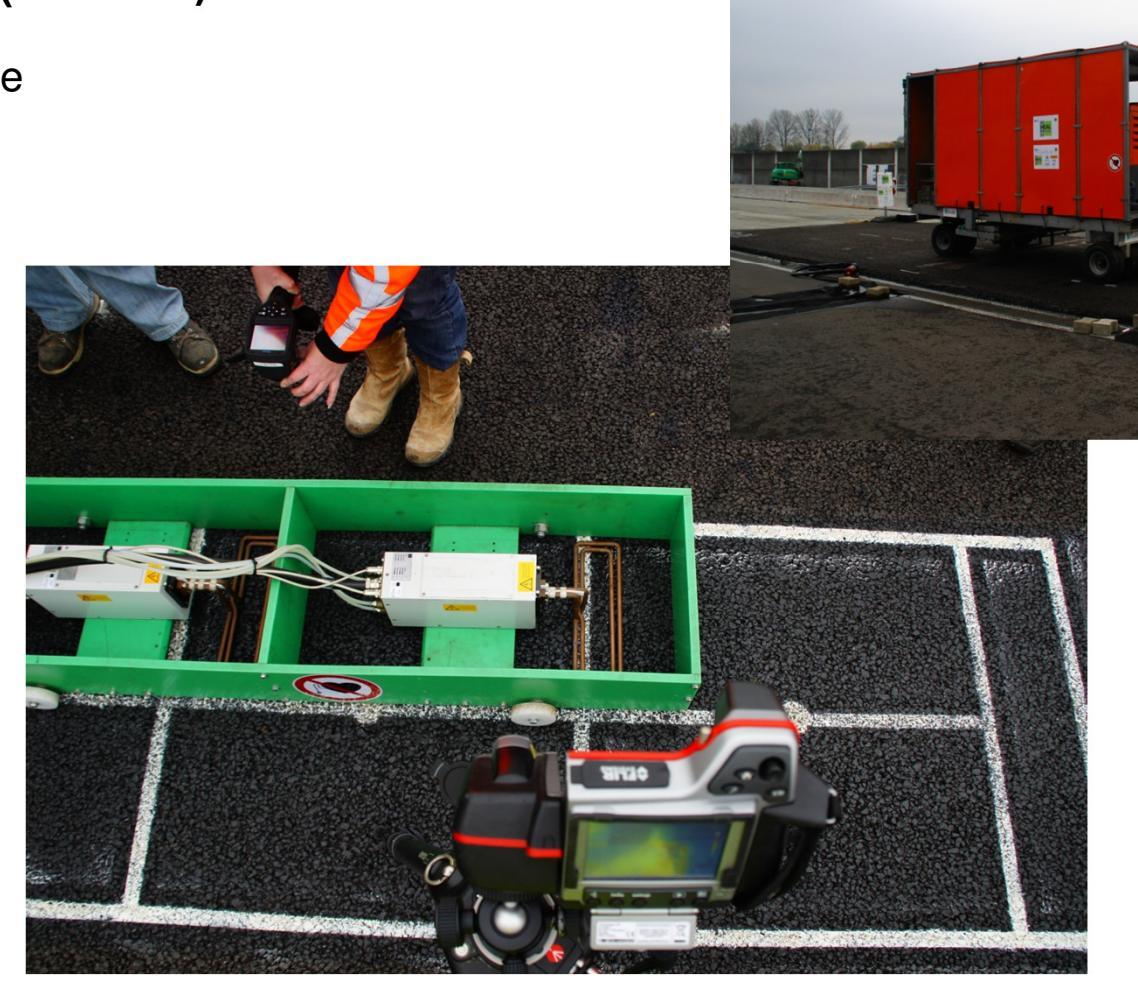
- details to Induction machine
 - 1400 Volt
 - 312 kHz
 - 33 Ampere
 - Energy 7-7,5 kW
 - 40 cm Coil (2 pieces)
 - Condensators: 4 x 0,33 μF

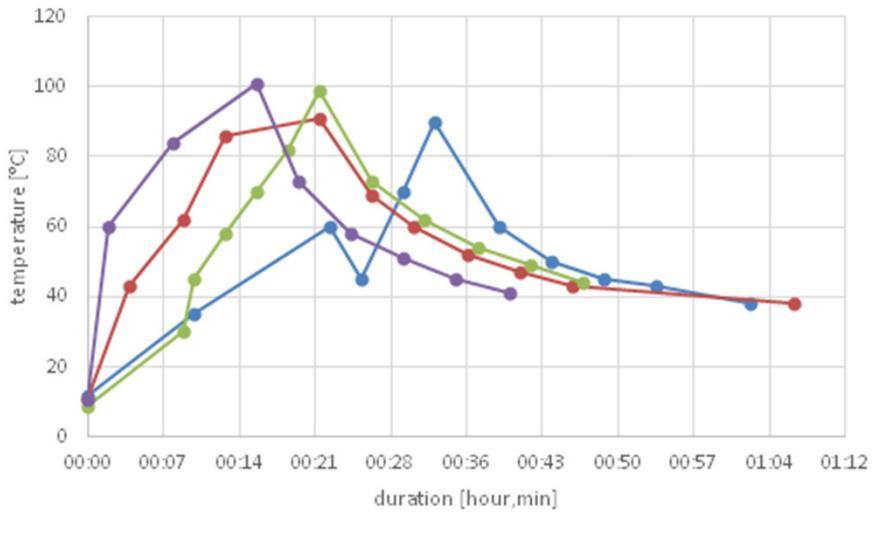
- healing actions
 - temperatures

____20%_s2r ____40%_s3r ____60%_s1I ____80%_s2I

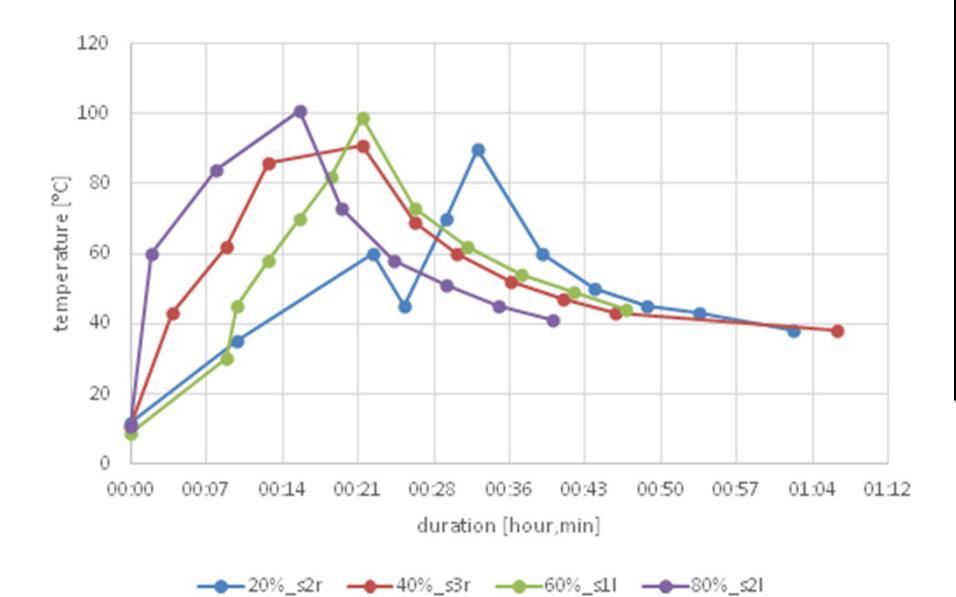
- healing actions
 - temperatures

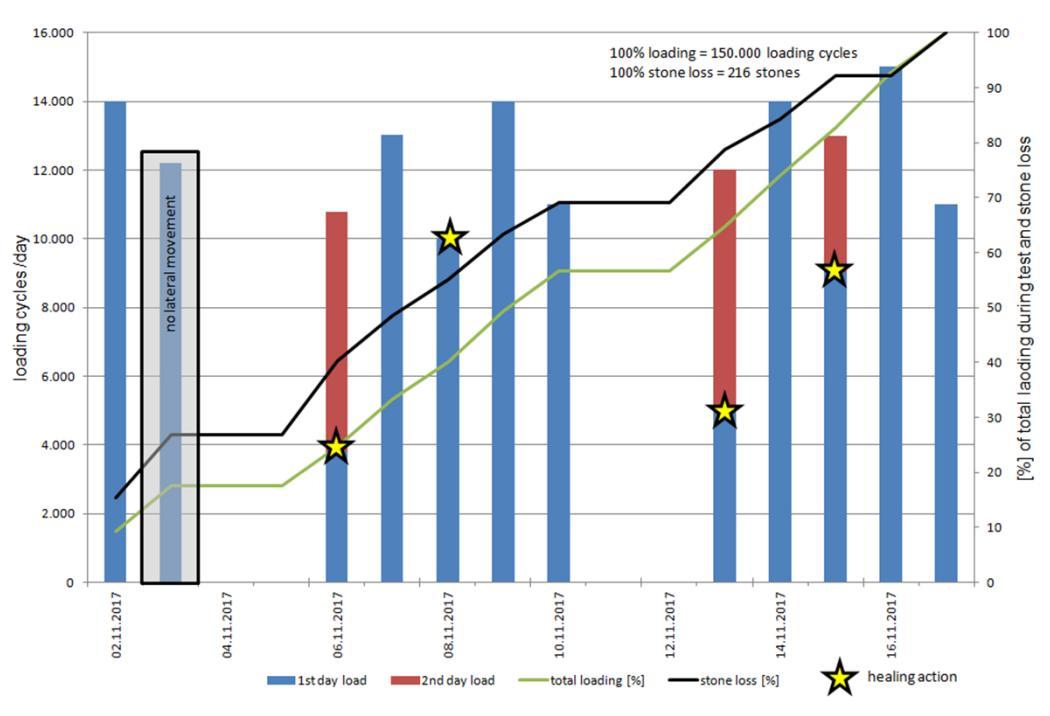
• surface inspection

dat o	gram	amount of stones	average weight of stone [gram]	stone loss progress (g/h)
02 x 17	5.5	33	0.17	0.64
ົ <mark>√ ∕</mark> ∠017	4.3	25	0.17	0.69
1 2017	_6_7 _	29	0.23	1.22
J7.11.2017	3.7	18	0.21	0.57
08.11.2017	1.5	 <u>14</u> 	0.11	0.29
09.11.2017	5	18	0.28	0.68
10.11.2017	1.6	12	0.13	0.29
13.11.2017	2.1	21	0.10	0.35
14.11.2017	1.1	12	0.09	0.16
15.11.2017	1.3	17	0.08	0.20
17.11.2017	5.8	17	0.34	1.05
Total	<u>38.6</u>	<u>216</u>	<u>0.18</u>	<u>0.56</u>
		IL STEED ones		0.92103

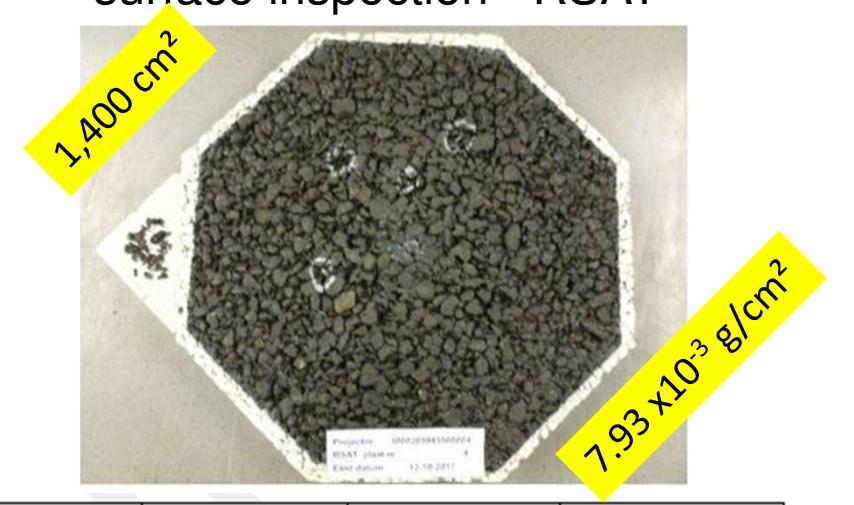
• surface inspection - RSAT

RSAT result	raveling -	initial	stone loss
	stone loss (g)	stone loss (g)	progress (g/h)
Slab 1	7.5	3.3	0.23
Slab 2	10.2	7.8	0.13
Slab 3	17.0	3.3	0.65
Slab 4	9.8	3.5	0.29
average	11.1	4.5	0.33

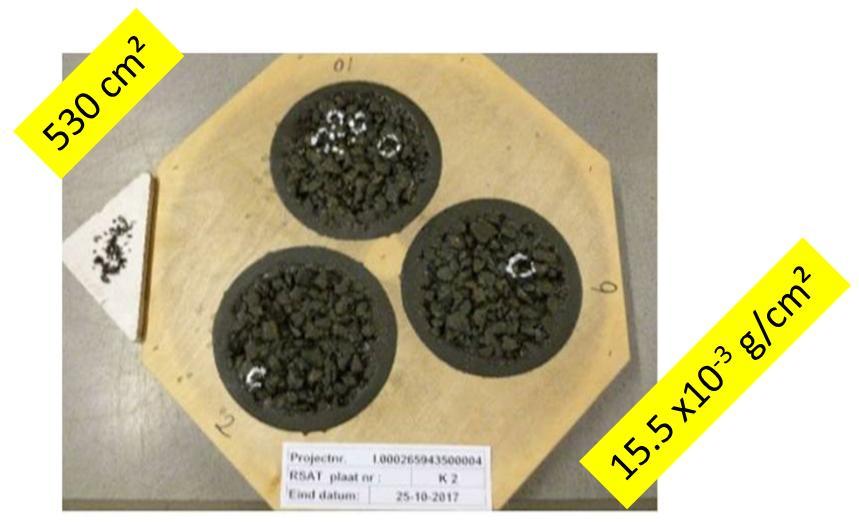
RSAT result	raveling -	initial	stone loss
	stone loss (g)	stone loss (g)	progress (g/h)
Cores Slab K1	9.6	1.6	0.34
Cores Slab K2	3.6	1.7	0.08
Cores Slab K3	9.7	0.1	0.38
Cores Slab K4	10.0	2.0	0.37
average	8.2	1.4	0.29
translation factor plates to cores	74 %	31 %	88 %

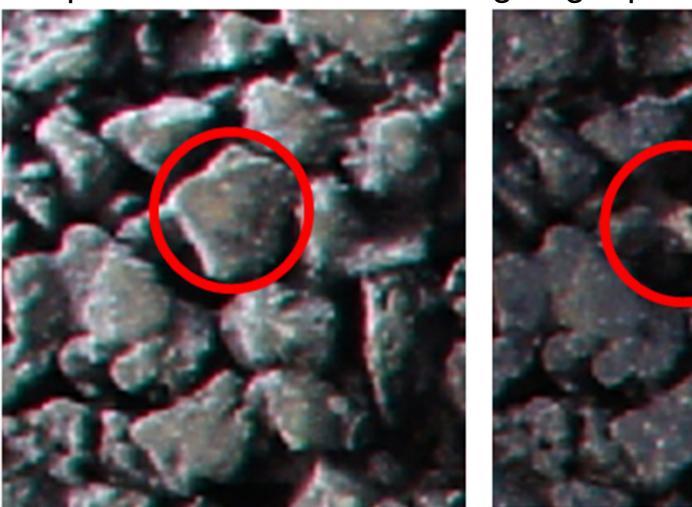
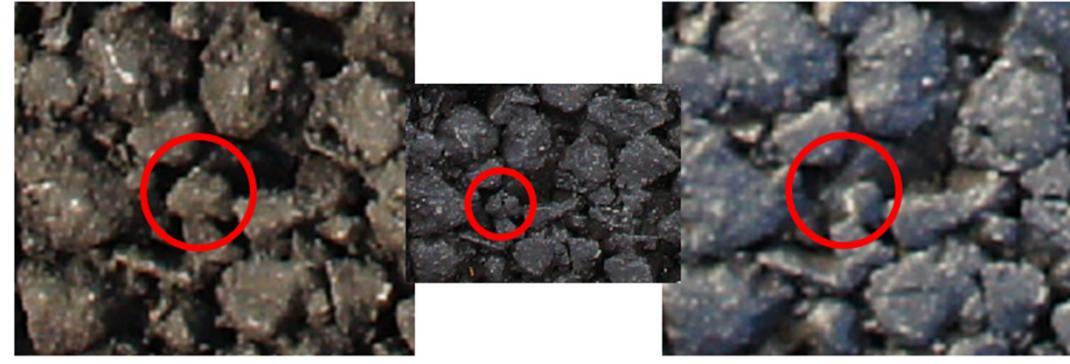
HR2-s1r_37-7_sl-com – left picture after 0 % of loading / right picture after 60 % of loading
